# Manhole Inspection Summary

Manhole # S29EE1060MH

Record Plat: **29EE1** Node: **060** Status: **New Manhole (Not in GIS)** Insp Date: **12/21/06 12:00 AM**

**Location** Address: **3910 KESWICK RD**

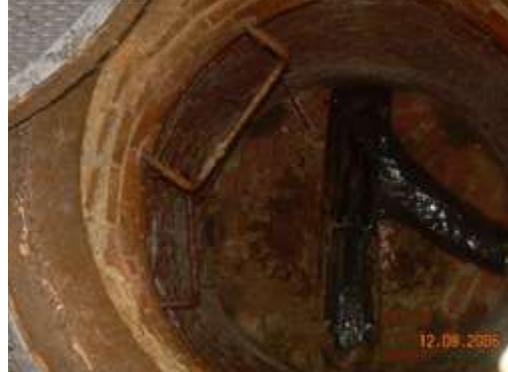
Top View

Frame leaks. Corroded steps. Evidence of surcharge - Bench debris. Channel debris.

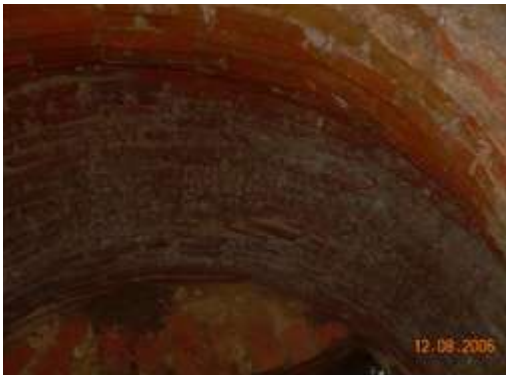
Defect

Adjustment, Corbel and Barrel infiltration.

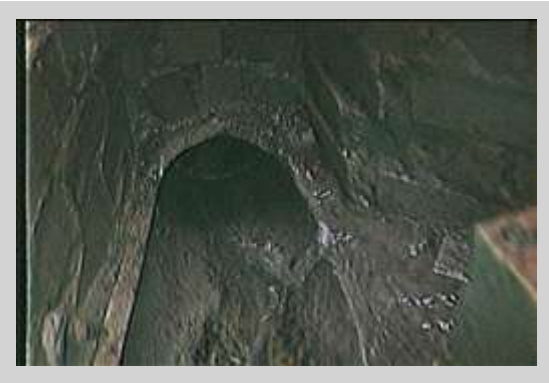
### 8 in. Circular Gravity Sewer Pipe Out @ 12 O'Clock

Channel deterioration.

Infiltration: **Evidence** Pipe Seal Cond: **Cracked**

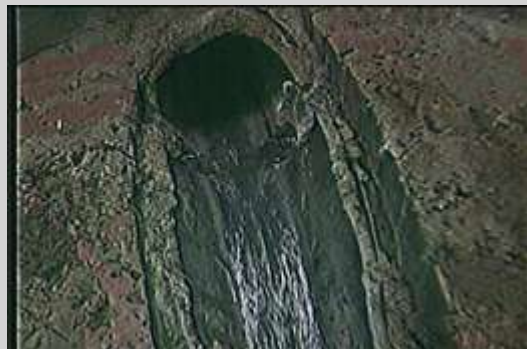
Pipe In @ 6 O'Clock

Infiltration: **Evidence**
